The post heating of vehicle wraps is fundamental to the success and longevity of vehicle wraps. Incorrect post heating will in most cases, result in lifting / popping of the film in places where the film is under pressure from conforming to the shape of the vehicle. Please refer to application guidelines for correct post heat temperature.

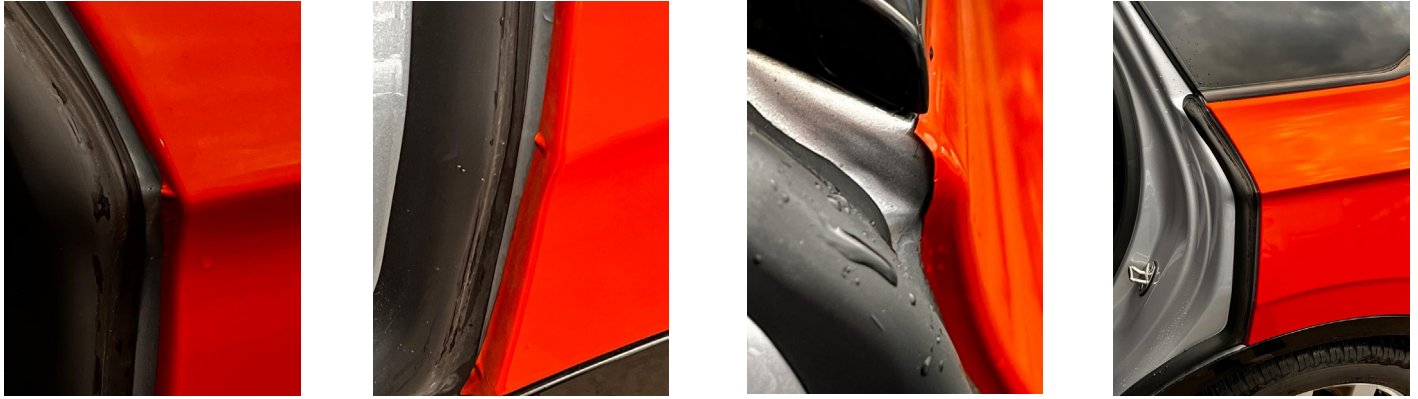
• No post heating

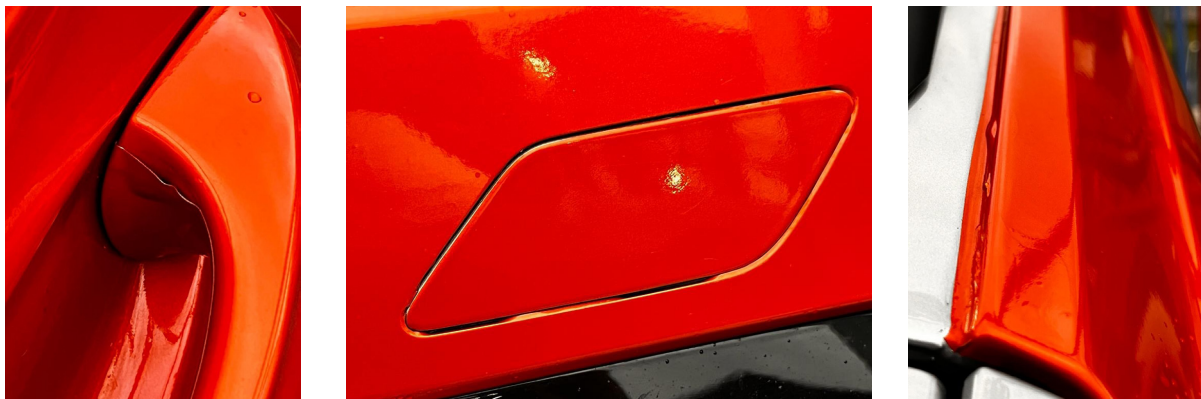
• Insufficient post heating upto 85°C

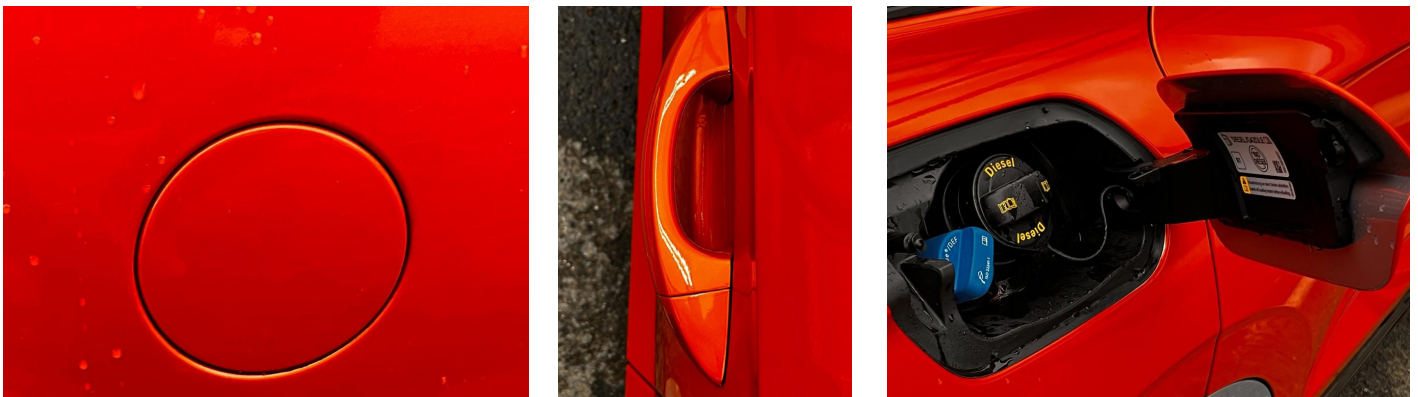
• Correct post heating
